PROJECT REPRESENTATIVE'S DAILY REPORT

Pg. 1
Report No. 055
Date: 2014-11-04
Day: Tuesday

Project: Renovation and Addition to Tewksbury Town Hall

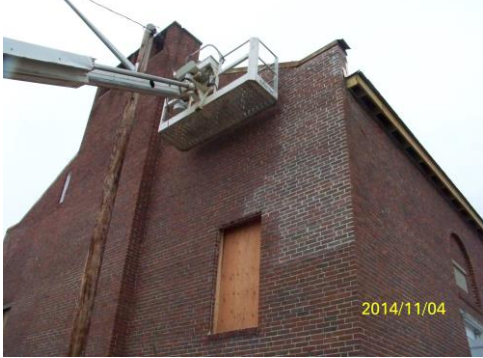
<p>Photo showing installed step flashing on the south side of the west end of the meeting hall.</p>

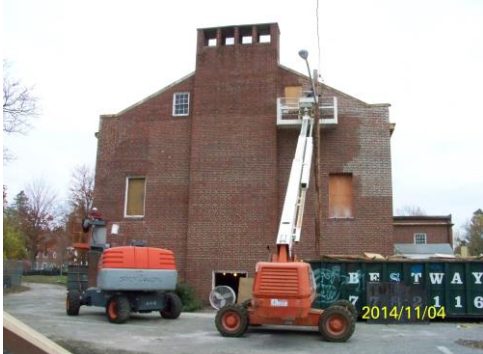
<p>Photo showing mason pointing on the west elevation.</p>

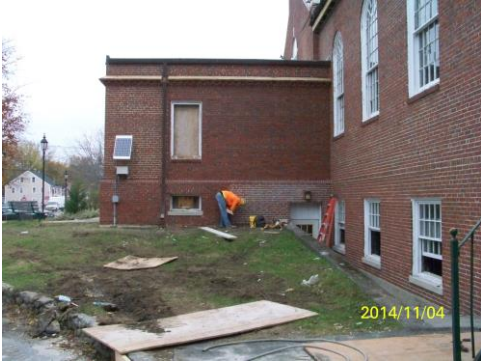
<p>Photo showing masons continuing to point on the west elevation.</p>
 	<p>Photo showing mason power washing on the south side of the south elevation.</p>

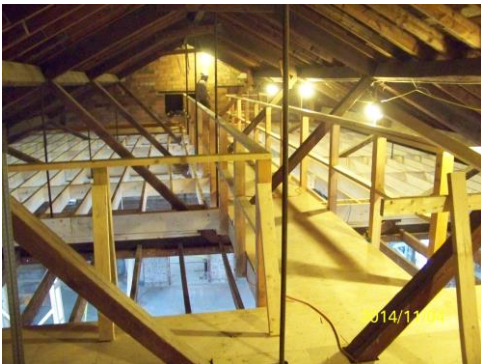
Photo showing HVAC platform almost complete.

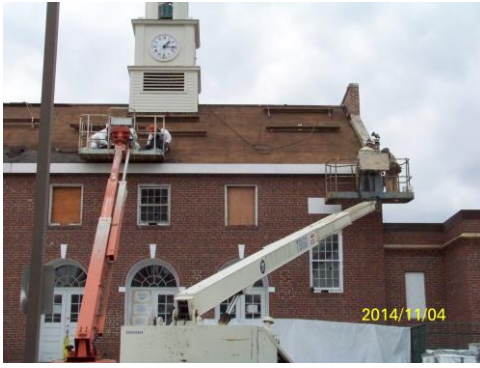
Photo showing balcony removed.
